# CASE STUDY: PEANUT MINE RECLAMATION PROJECT; GUNNISON COUNTY, COLORADO

### Steve Renner

### **ABSTRACT**

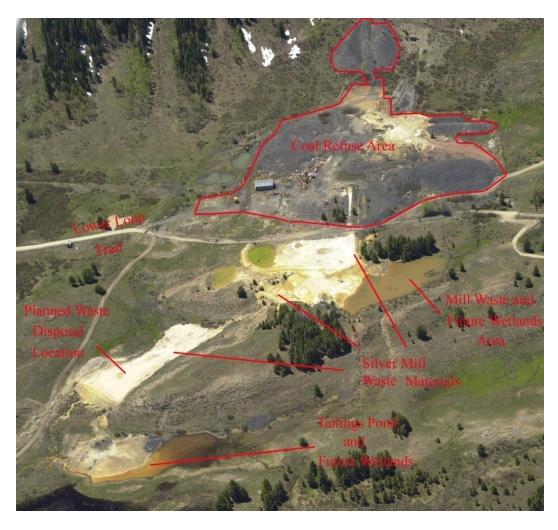
Figure 2. Aerial View of Sixteen Acre Peanut Mine Site, With Locations of Coal Refuse Materials and Silver Mill Wastes.

The milling facility was constructed on the west side of the Peanut Mine site. Ore was brought to the site, stockpiled and processed at the west side mill. Mill waste materials were deposited at

the east side of the Peanut Mine. This mill waste was accumulated in both constructed tailings ponds and in naturally occurring topographic depressions.

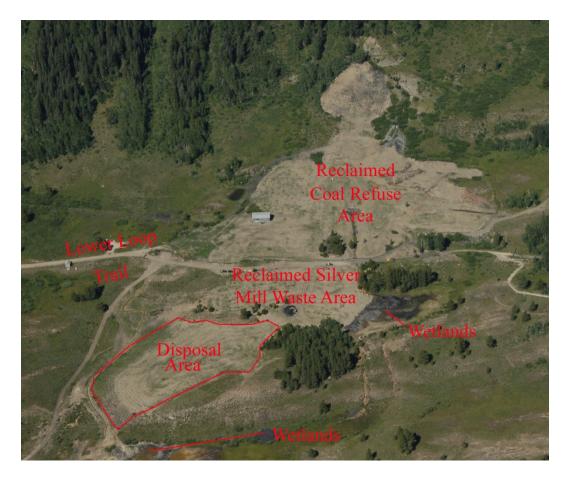
Figure 3. Aerial View of Peanut Mine, Early Summer Following Completion of Reclamation Construction.
